MASTER PLAN for

AUGUSTA COUNTY GOVERNMENT CENTER

VERONA, VIRGINIA

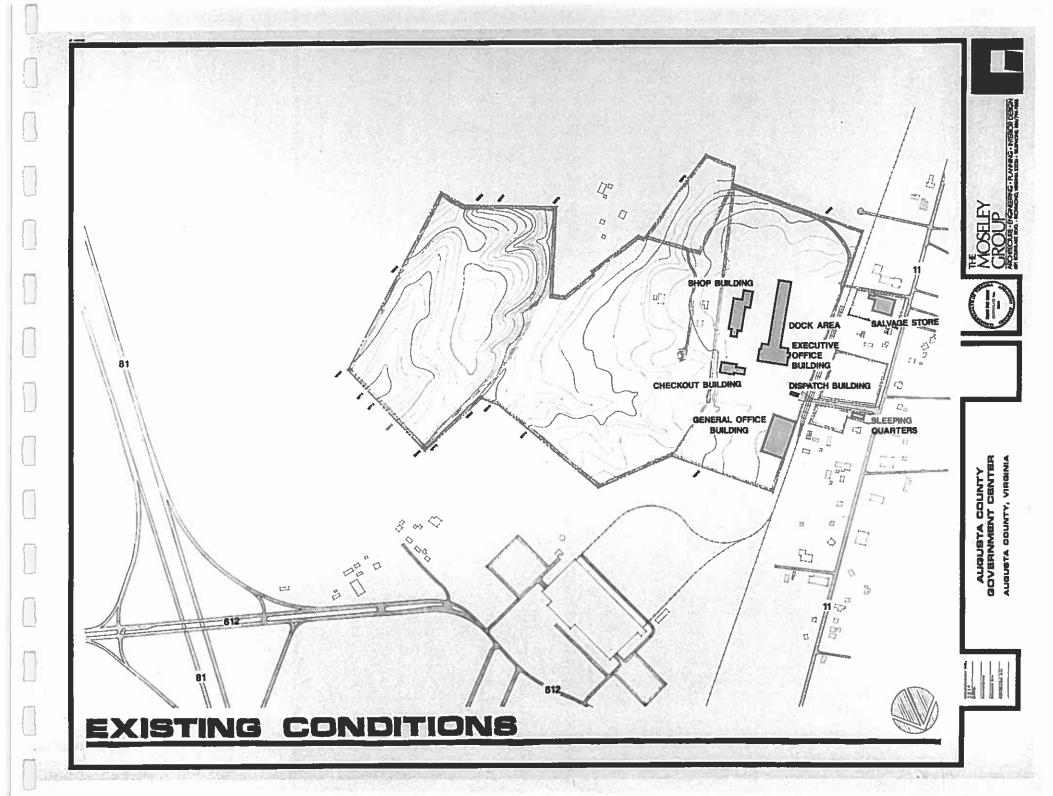
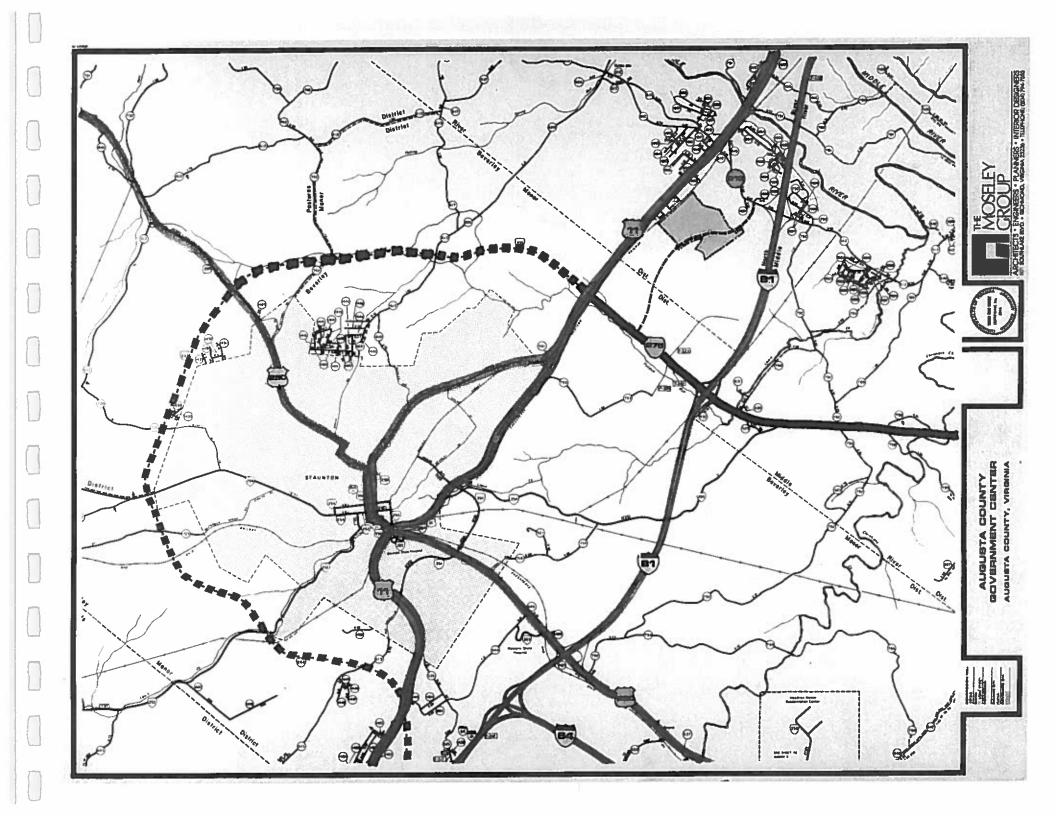
The exhibits on the following two pages illustrate conditions at the Government Center site at the time of its purchase, and the transportation network, both existing and proposed, in the surrounding area.

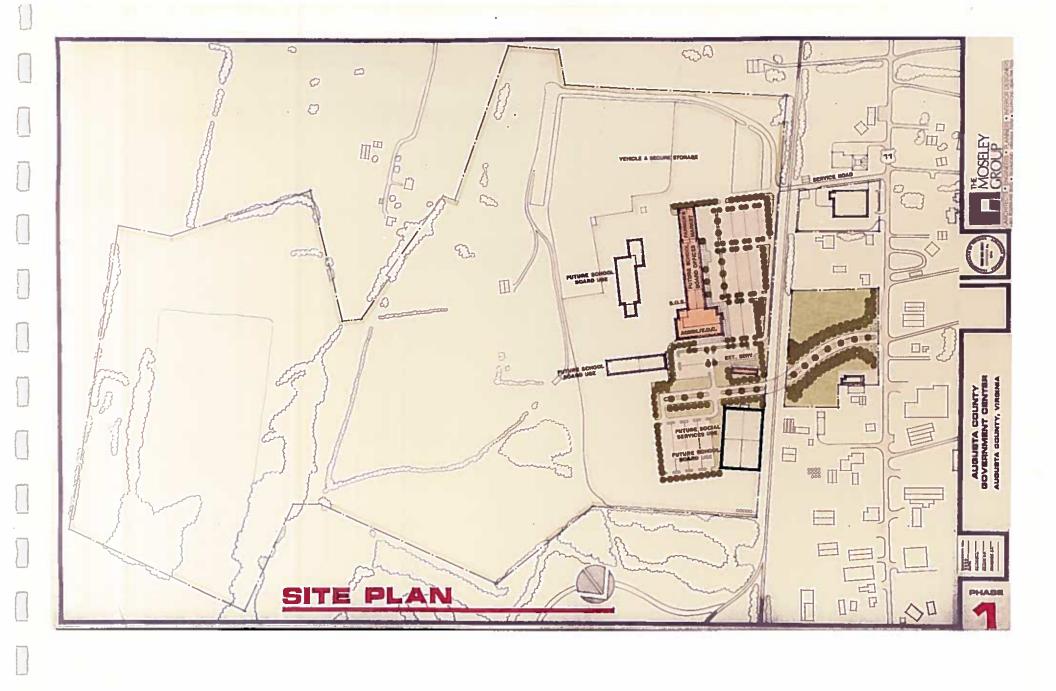
PHASE I

Phase I includes construction of approximately one-third of the east-west boulevard, and conversion of the paved area adjacent to Route 11 into a landscaped lawn appropriate to the scale and community significance of the Government Center. The "Executive Office Building" will be renovated to function as the County's Administration Building, including a Board of Supervisors meeting room. The attached "Loading Dock" will be partially enclosed to provide additional space for administrative functions. Other improvements will be made to the Dock as well, including a new roof. The "Dispatch Building" will be improved for use by the County's Virginia Cooperative Extension Service office.

Landscaping, drainage and paving improvements will be made in the parking areas west and north of the Administration Building to make them suitable for public and staff use. Similar but less extensive improvements will be made in the area east of the "General Office Building," which will serve as an interim location for the County Treasurer, Commissioner of the Revenue, and Registrar, prior to completion of the Administration Building.

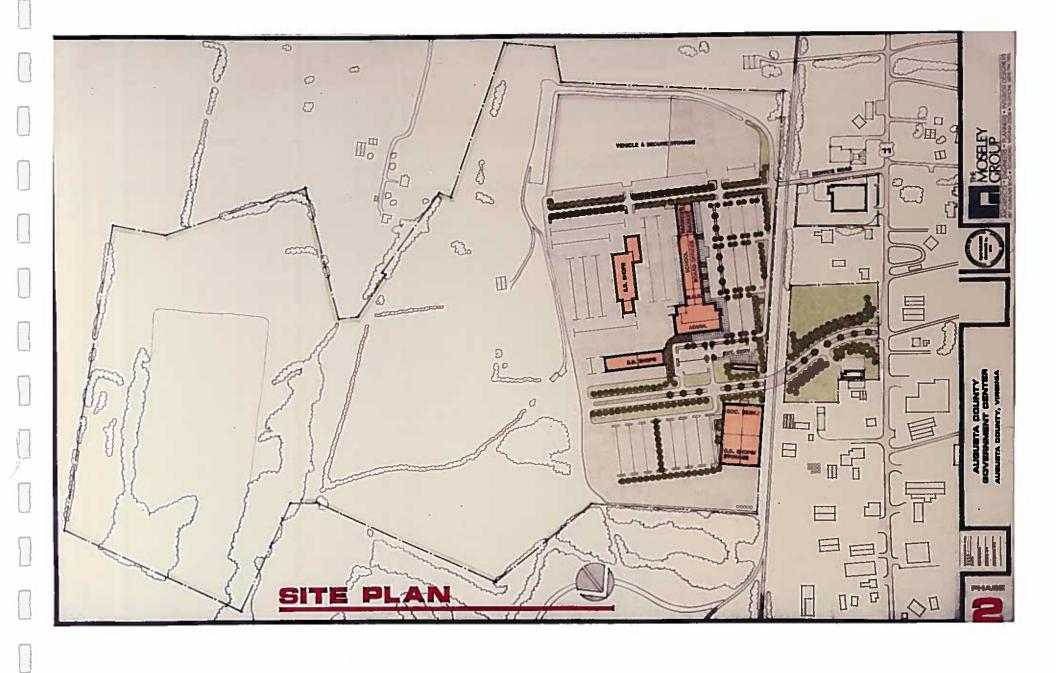
PHASE II

In Phase II of the Master Plan, the south (office) portion of the General Office Building will be adapted for use by the County's Social Services Department. Additional site improvements and landscaping will also be implemented, including improvement of the service road from Route 11 for use by school buses and service vehicles. The east-west boulevard will be extended further to the west to access expanded parking areas.

Phase II also involves relocation of the School Board's facilities to the Government Center. The administrative and educational offices, which require approximately 33,385 square feet of space, would initially be located on the "Loading Dock," most of which would be completely enclosed and refurbished as office space. The School Board would share use of the Board of Supervisors' room for public meetings.

The School Board's vehicle maintenance, shop, and storage functions, which require approximately 163,200 square feet, would be housed in the "Check-Out Building," the "Shop Building" and the north (warehouse) portion of the General Office Building. These structures are well suited for their intended functions, which closely parallel their former uses.

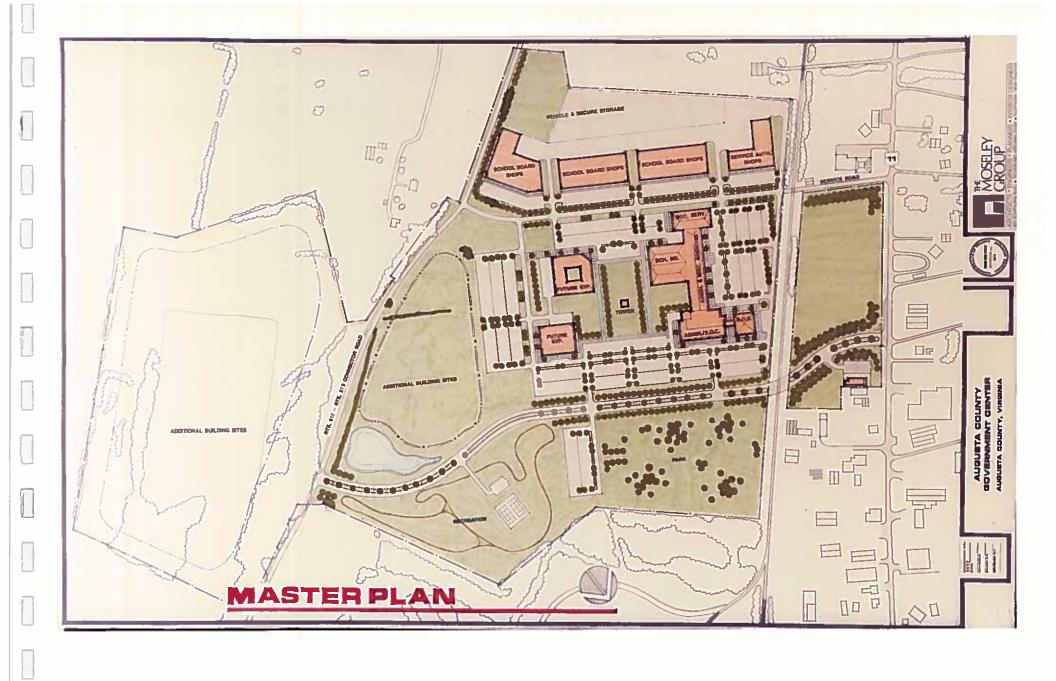
LONG RANGE PLAN

After implementation of Phase II, long range plans are to eventually phase out the Shop, Check-out, Dispatch, and General Office Buildings, which are less substantial structures with a limited useful life. As each is phased out, new construction will be Implemented to replace it if necessary. School Board maintenance and shop functions will be located south of the service road, which will be extended through to the 612-275 connector. The Service Authority shops can also be located here, with ample area behind for vehicle storage and service yards. Overall, this will create a service zone separate from the Administrative zone, which will be consolidated by construction of additions to the Administration Building for the School Board and Social Services as their respective space needs grow. In addition, a new and larger Board of Supervisors room may be needed, and it may become desirable to provide space for lease by State and Federal agencies which serve the public.

additional public buildings if they are needed, along with the necessary parking and vehicle circulation. The area north of the boulevard would be reserved as open space, and could be developed for low intensity recreational use. A storm water retention pond is recommended to handle the increased pavement run-off and would provide an attractive amenity for this area.

The "Sleeping Quarters" is adaptable for a variety of possible uses. The "Salvage Store" is in disrepair and cannot be economically restored for long term County use. It may be more attractive for private enterprise; if not, it should eventually be demolished. Acquisition of the commercial property immediately to its north would allow the opportunity to consolidate an open green space along a significant portion of the Government Center frontage. As the Verona area develops further, this may provide a welcome oasis, in addition to serving as an appropriately scaled "front lawn" for the Government Center.

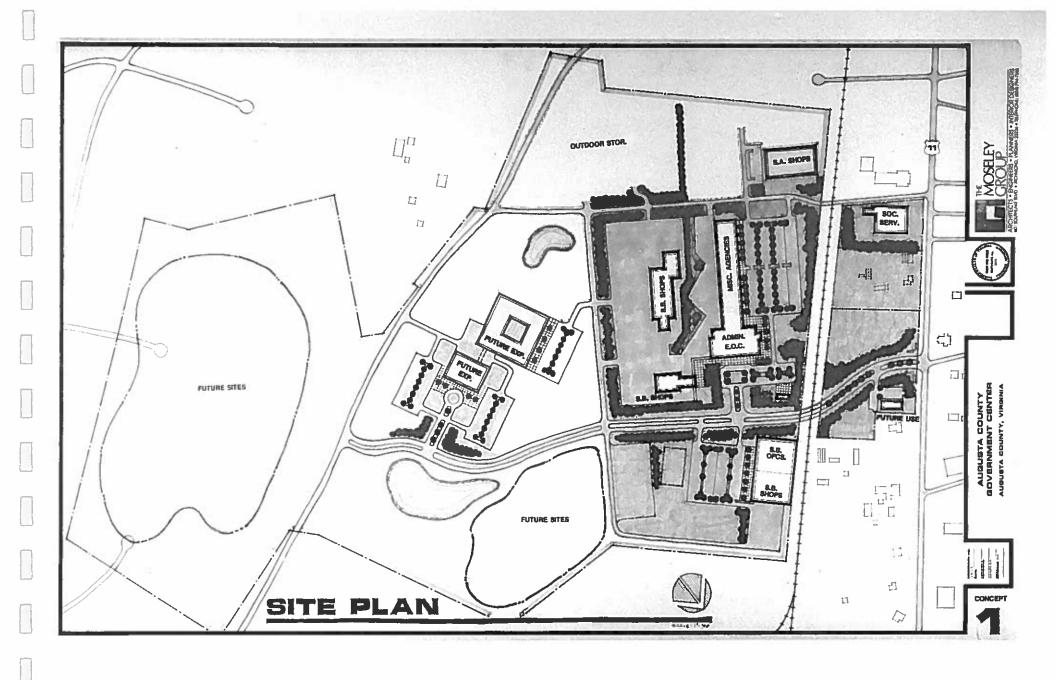
Master Plan Concept One

This Concept utilizes all existing buildings on the property. Construction of additional space is not included in the first three phases of the project (Administration, Social Services and School Board), however, square footages available in the existing buildings are somewhat less than that of programmed 20 year needs. The Dock area is renovated for Farmer's Market/Special Events space, with the option of enclosing it at a later date for use as office space.

<u>Phase</u>	20 Year Needs (G.S.F.)	Available Space (G.S.F.)
1A	ADMINISTRATION & E.O.C. Renovate existing Executive Office Building and Dispatch Building	83,275	78,160
1B.	Renovate Dock for use as Farmer's Market/Special Events Space		38,252

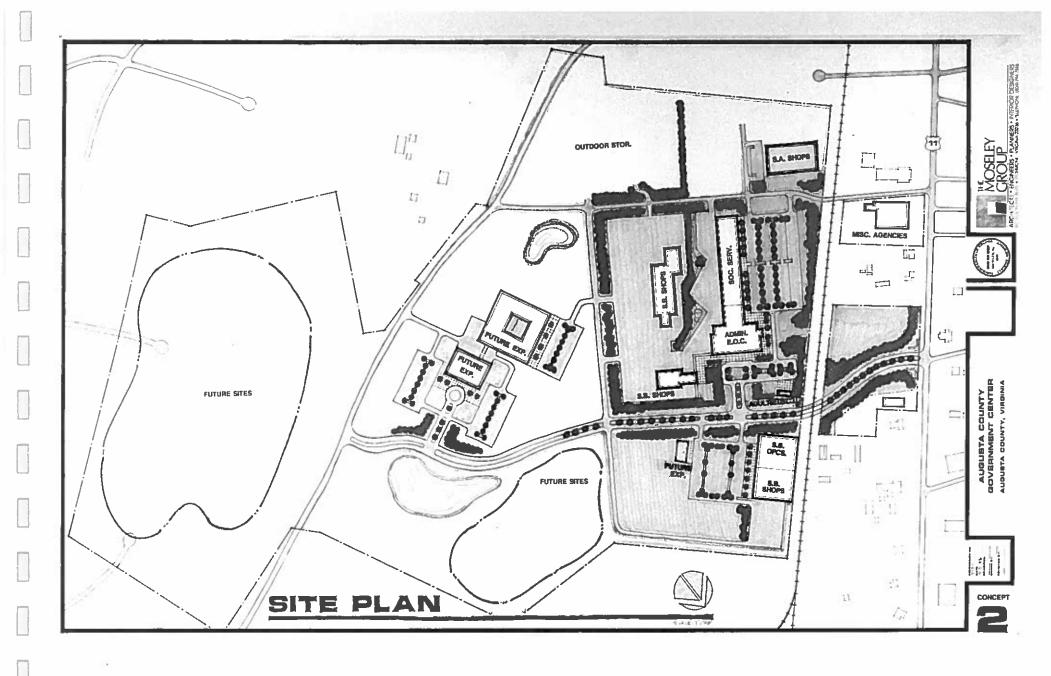
Master Plan Concept Two

This Concept is similar to Concept One, except that the Dock area is enclosed as office space to satisfy 20 year needs of Administration and Social Services. Similarly, the School Board is brought closer to 20 year needs by the addition of a second level within the warehouse portion of the General Office Bullding. This Concept includes the sale of the Salvage Store property to private interests.

<u>Phase</u>	20 Year Needs (G.S.F.)	Available Space (G.S.F.)
1A.	ADMINISTRATION & E.O.C. Renovate existing Executive Office Building	83,275	71,770
1B.	ADMINISTRATION. Partially enclose / renovate Dock to accommodate balance of Administration	11,505	11,505

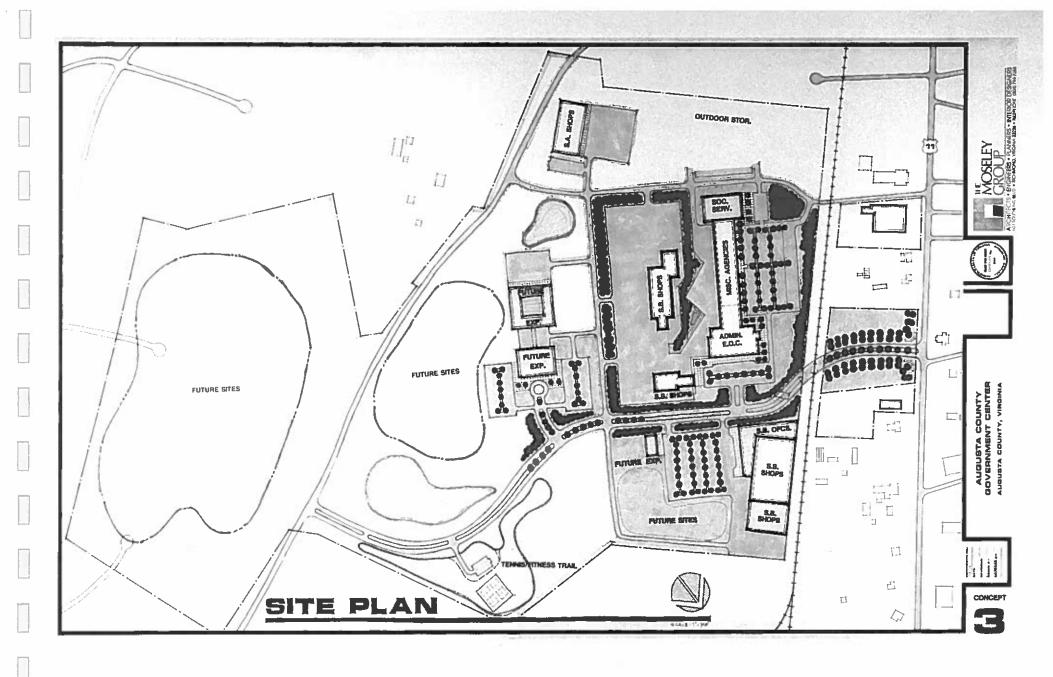
Master Plan Concept Three

This Concept goes a step further than Concept Two by not only enclosing the Dock, but by also utilizing Additions to the General Office Building and the Dock to bring Social Services and the School Board to 20 year programmed needs. The Dispatch Building is demolished to allow more generous clearance for the Government Center entrance drive and the addition to the General Office Building. This Concept also includes the sale of the Salvage Store and the Sleeping Quarters properties to private interests.

Phase	20 Year Needs (G.S.F.)	Available Space (G.S.F.)
1A.	ADMINISTRATION & E.O.C. Renovate existing Executive Office Building and demolish Dispatch Building	83,275	71,770
1B.	ADMINISTRATION. Partially renovate / enclose Dock to accommodate balance of Administration	11,505	11,505
2A .	MISCELLANEOUS STATE & FEDERAL AGENCIES. Renovale Dock	24,813	26,747

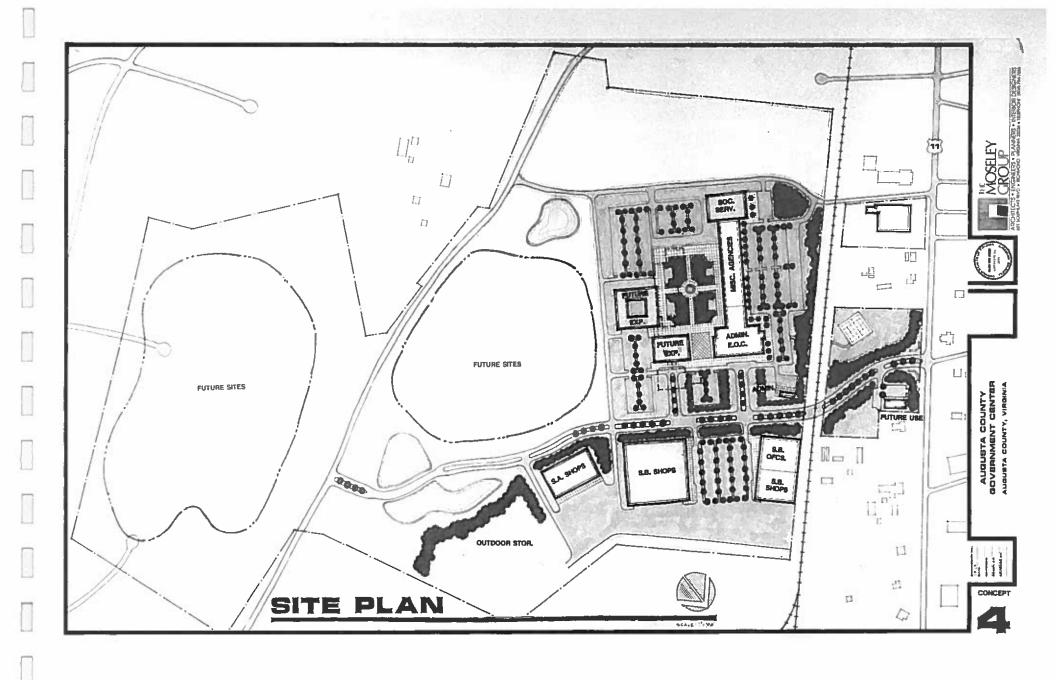
Master Plan Concept Four

This Concept produces a compact Government Center with close proximity of buildings. After serving their useful lives, the Shop Building and the Check-Out Building would be demolished, making available sites for future use/expansion. New School Board shop and maintenance facilities would then be constructed along the north side of the Government Center Drive.

Phase	20 Year Needs (G.S.F.)	Available Space (G.S.F.)
1A	ADMINISTRATION & E.O.C. Renovate existing Executive Office Building and Dispatch Building	83,275	78,160
1B.	ADMINISTRATION. Partially renovate / enclose Dock to accommodate balance of Administration and future expansion	11,505	11,505
2 A .	SOCIAL SERVICES. New addition to expand Dock	23,092	23,092
2B.	MISCELLANEOUS STATE & FEDERAL AGENCIES. Enclose Dock	24,813	26,747
3A.	SCHOOL BOARD OFFICES. Renovate office area of General Office Building	37,935	34,675
3B.	SCHOOL BOARD SHOPS AND STORAGE. Renovate remainder of General Office Building; add second level	163,200	57,738
3C.	SCHOOL BOARD SHOPS AND STORAGE. Renovate Shop & Check- Out Buildings		64,600

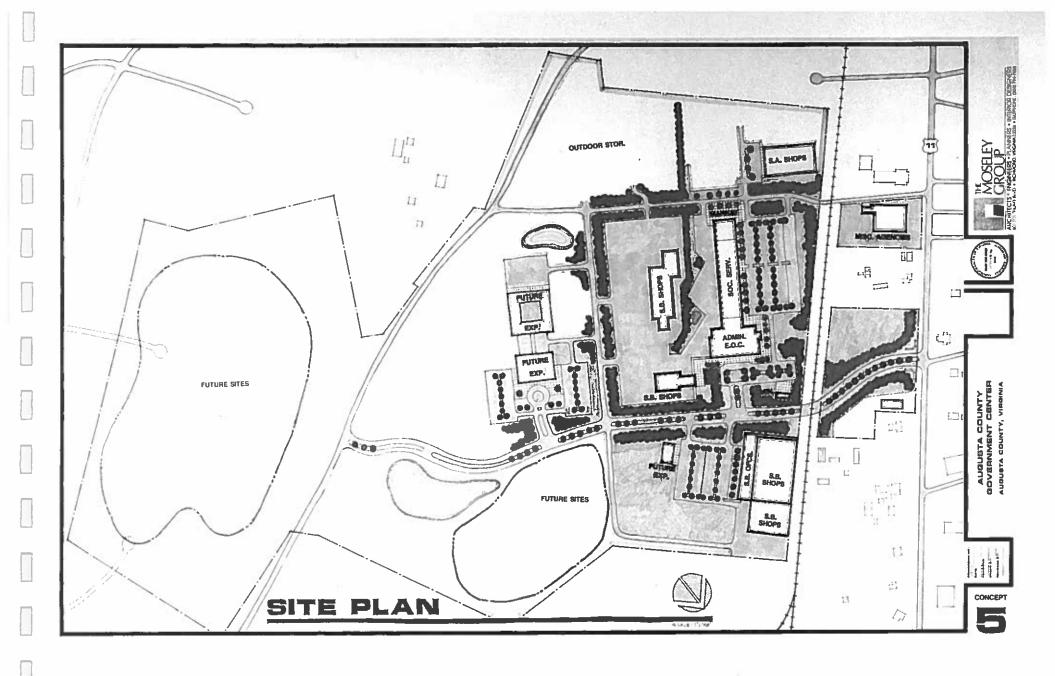
Master Plan Concept Five

This Concept encloses the Dock and involves Additions to the General Office Building to meet 20 year needs. A 10,000 square foot portion of the Dock is left unenclosed as Farmer's Market/Special Events space. The Sleeping Quarters is sold to private interests.

Phase	20 Year Needs (G.S.F.)	Available Space (G.S.F.)
1 A .	ADMINISTRATION & E.O.C. Renovate existing Executive Office Building and Dispatch Building	83,275	78,160
1B.	ADMINISTRATION. Partially renovate / enclose Dock to accommodate balance of Administration	5,115	5,115
